SERVICE BULLETIN - SB030

Doc. No.:	SB030
Revision:	00
Rev. Date:	25/07/2022

I.C.P. Srl

SERVICE BULLETIN 30 - Exhaust manifolds welding for Rotax 912

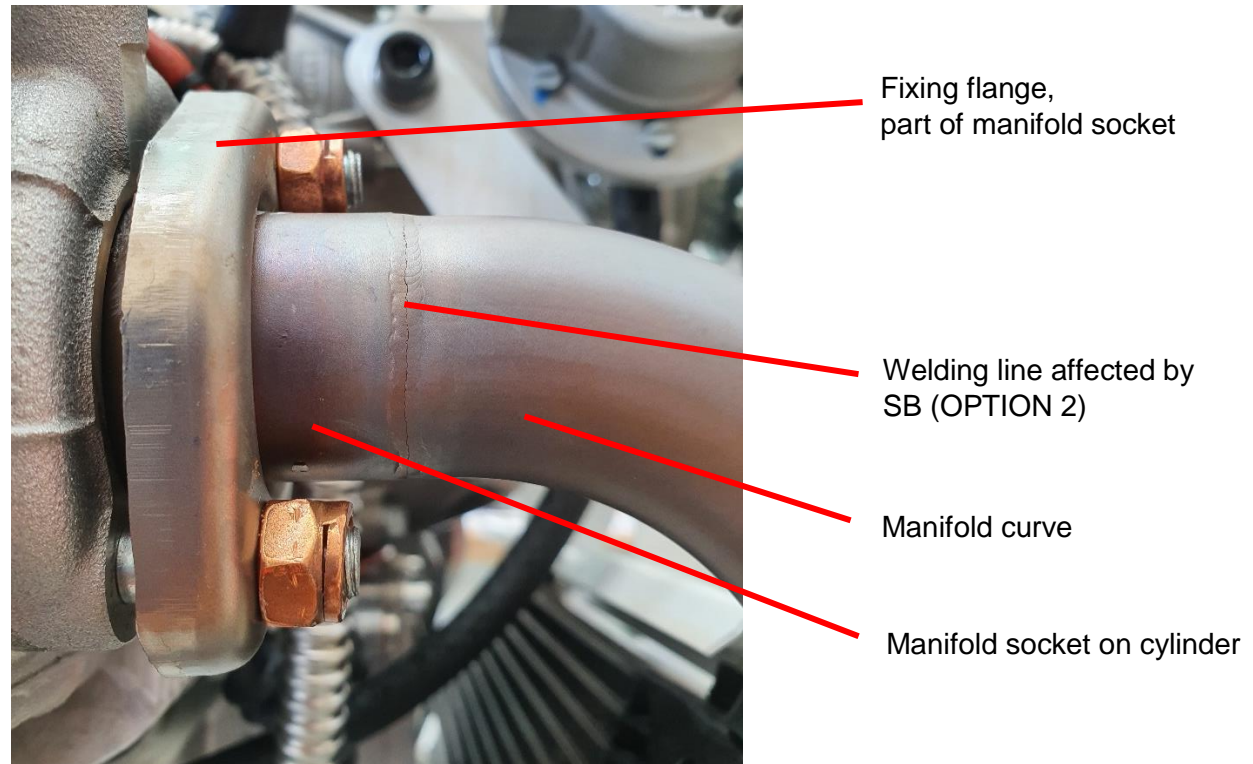
Figure 1: Exhaust manifold

The exhaust manifolds, steel pipes from engine to exhaust muffler, which are equipped on Rotax 912 series engines of ICP aircrafts, are the parts affected by the present SB (see *Figure 1*).

The exhaust manifolds of the engine Rotax 912 model are 4 steel pipes composed mainly by two parts welded together, the ones straight connected and constrained directly to the engine cylinders and the curved ones, which is then connected to the exhaust muffler. Some welding of these parts were found cracked within few hours of flight, in different aircrafts. The part is shown in *Figure 1*.

Ferry flight of maximum 3 hours is allowed to reach maintenance facility only if accurate inspection of the manifolds welding (see *Figure 1*) is performed and no visible crack or imperfections are found.

Apply the same procedure of Option 1 excluding the installation of "spare new exhaust manifolds". Use the old manifolds and perform a new welding of the socket to the manifold curve, refer to *Figure 1*. It is necessary to request ICP an approval to perform this option; basically it must be demonstrated that the welding is operated by a certified welder workshop.
